**PRELIMINARY ASSESSMENT/  
VISUAL SITE INSPECTION**

**KALMUS AND ASSOCIATES, INC  
BROADVIEW, ILLINOIS  
ILD 005 066 923**

**FINAL REPORT**

**U S ENVIRONMENTAL PROTECTION AGENCY  
Office of Waste Programs Enforcement  
Washington, DC 20460**

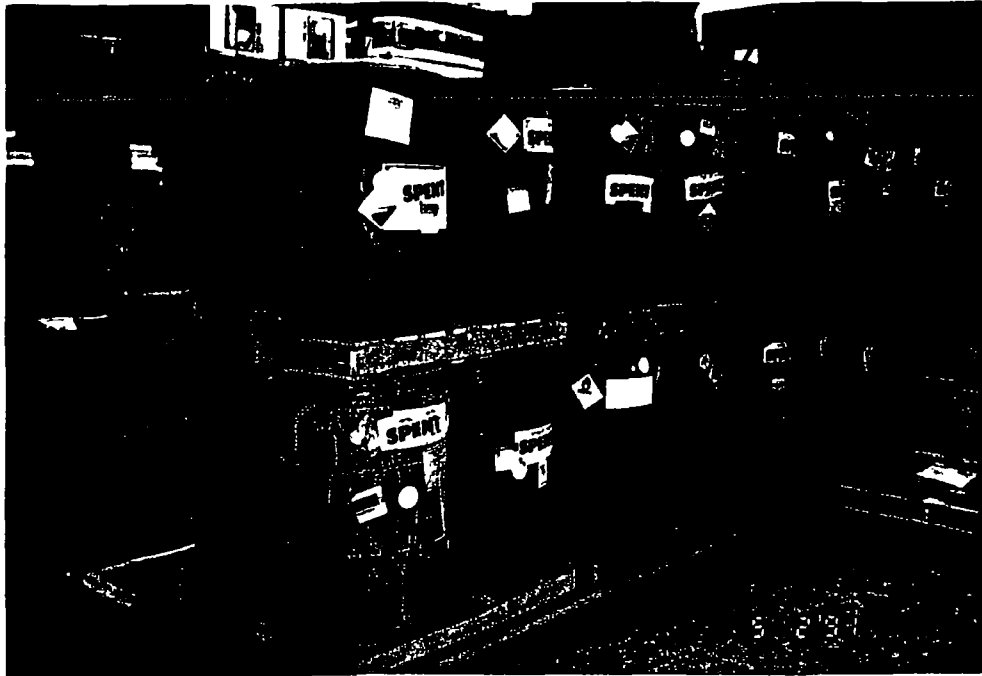
**Photograph No 1**

**Description** This area stores 55-gallon drums of hazardous and non-hazardous wastes. Drums are stored on wooden pallets. The floor is coated with an alkyd based, acid- and alkali proof paint.

**Location SWMU 1**

<b>Release Controls</b>	The concrete floor is coated with an alkyd based, impermeable alkali and acid proof paint. The drums are stored on wooden pallets. There are no floor drains in the vicinity of the storage area.
<b>History of Release</b>	There has been no documented release from this unit.
<b>Observations</b>	The drums are in good condition, and are clearly labelled.

**Conclusions** This is an area used to store 55 gallon drums of hazardous and non hazardous wastes. The concrete floor is sound and is covered in an alkyd based paint. The drums are stacked on pallets. The potential for release to ground water, surface water, air or soil is low as the unit is located indoors.

**Recommendations** No further action is recommended at this time.

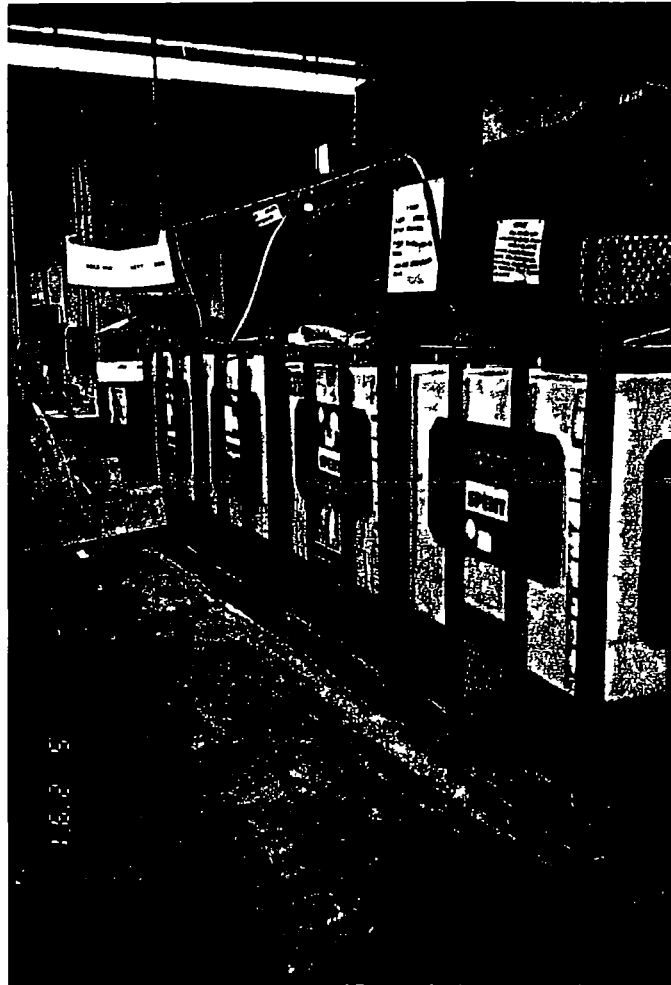
**Photograph No 5**

**Description** These are the portable containers used to store spent ammonium persulfate and potassium peroxydisulfate etchants. They have metal frames, and are moved to the dock area prior to hauling.

**Conclusions** This unit is used to store 300 to 500 gallon capacity containers of hazardous wastes It is located indoors on a sound concrete floor All containers are in good condition Therefore, the potential for release to ground water surface water air or soil is considered low

**Recommendations** No further action is recommended at this time

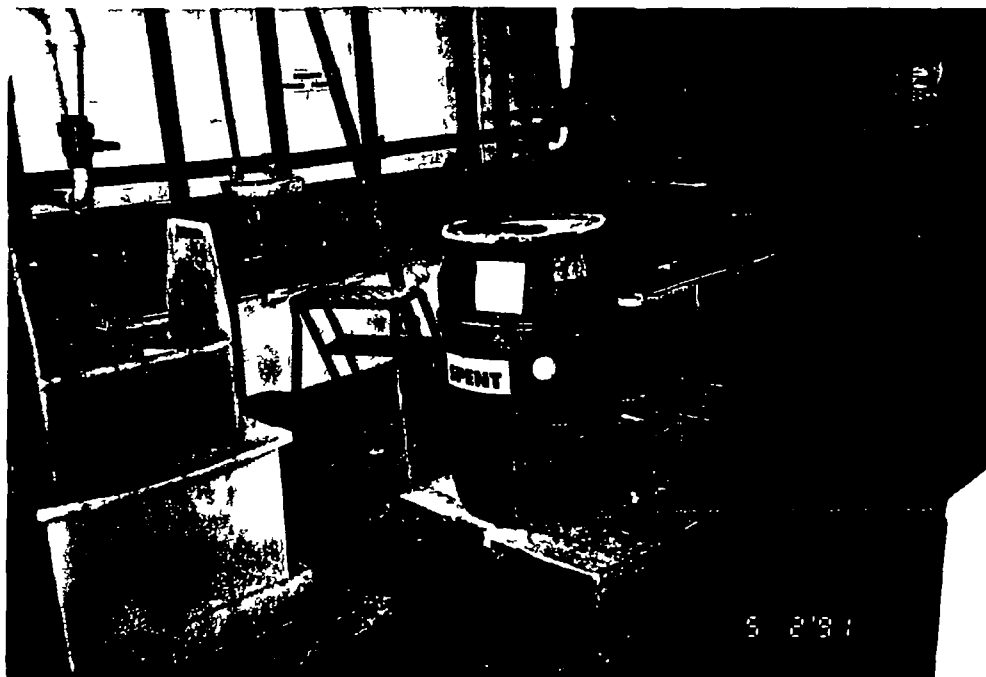
**Photograph No 6**

**Location SWMU 6**

**Conclusions** These areas consist of 55 gallon drums used to accumulate wastes at or near the points of generation The drums have lids and are in good condition They are stored on pallets The potential for release to ground water, surface water air or soil is considered low

**Recommendations** No further action is recommended at this time
